**MEMORANDUM OF AGREEMENT  
SUBMITTED TO THE ADVISORY COUNCIL ON HISTORIC PRESERVATION  
REGARDING  
UPPER OHIO NAVIGATION STUDY, PENNSYLVANIA**

**WHEREAS**, the U.S. Army Corps of Engineers, Pittsburgh District (Corps), through the Upper Ohio Navigation Study, Pennsylvania, is recommending a modernization plan for replacement of lock chambers at Emsworth, Dashields, and Montgomery Locks and Dams in Allegheny and Beaver counties, Pennsylvania; and

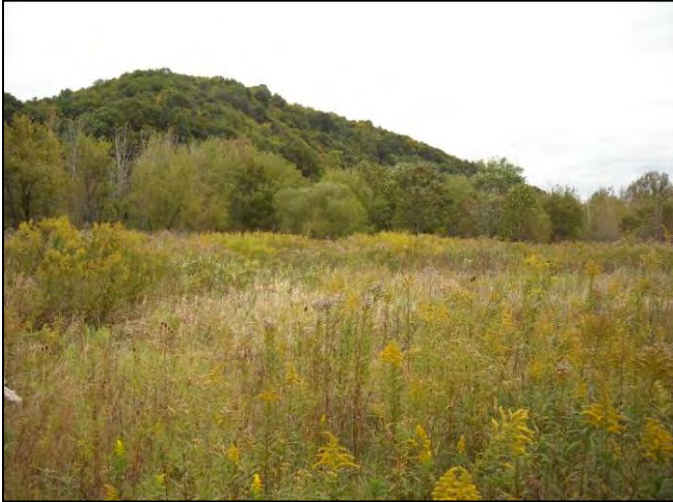
***Photograph 8. Overview of Field in Center of Disturbed Eastern Portion of SA 14. View East.***

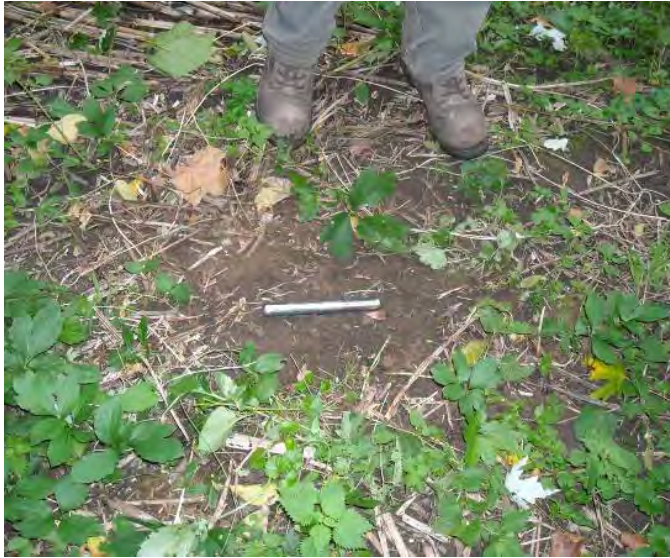
Field investigations included a ground reconnaissance and limited use of a soil probe to examine soils, followed by selective shovel test pit excavations (Photographs 9 and 10). The pedestrian reconnaissance and soil probe activities evaluated the potential for intact soils (and archaeological remains) in SA 14. The field investigations divided

***Photograph 9. Soil Probe Inserted to Handle in Fill.***

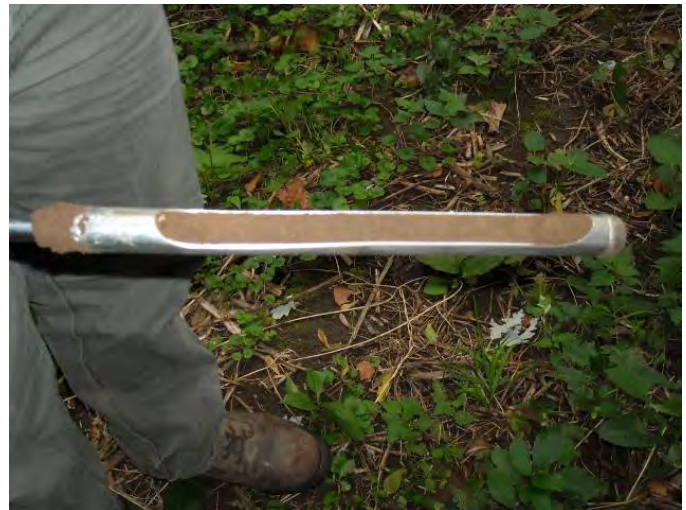
***Photograph 10. Soil Probe with Fill Soils.***

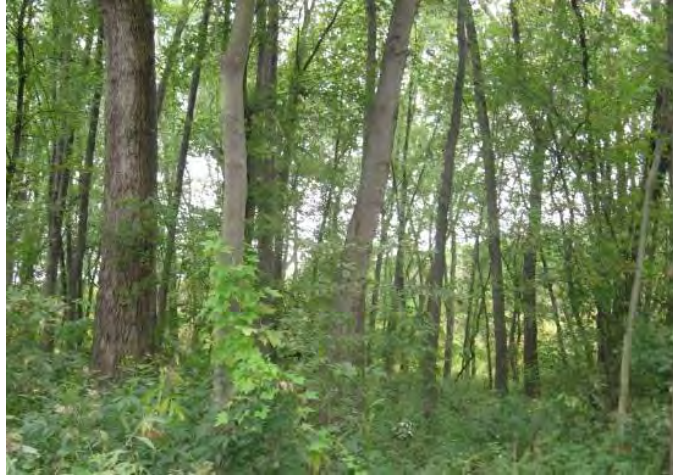
Aerial photographs indicated that the peninsula remained forested from at least as early as 1939. Pedestrian reconnaissance revealed that most of this forest had relatively young trees (Photograph 11). An area within the boundary of Site 36BV9 on the peninsula was selected for confirmation that fill deposits covered this area.

***Photograph 11. Overview of Forest on Peninsula of SA 14. View West. (Photograph Courtesy of Aerostar Environmental Services, Inc.)***

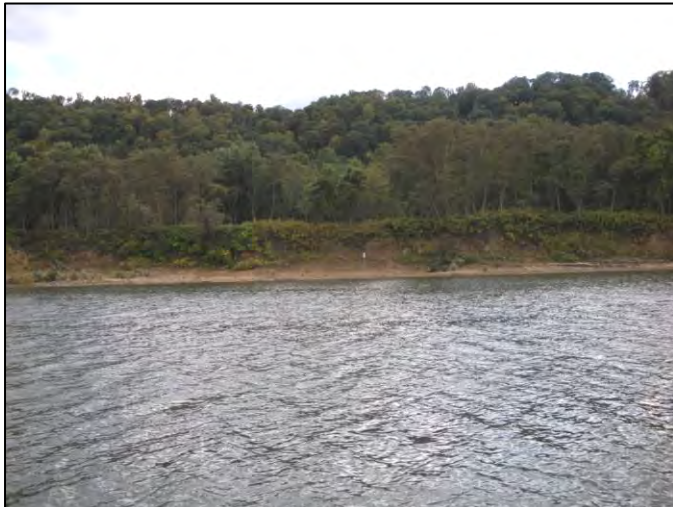
Study Area 16 was viewed by boat on October 6, 2009. There was no visible evidence of any archaeological remains along the shoreline. Erosion was clearly visible on the northeastern end of the island. Vegetation obscured much of the view on the southern and western banks (Photograph 12).

***Photograph 12. Overview of SA 16 showing Shoreline Erosion. View South.***

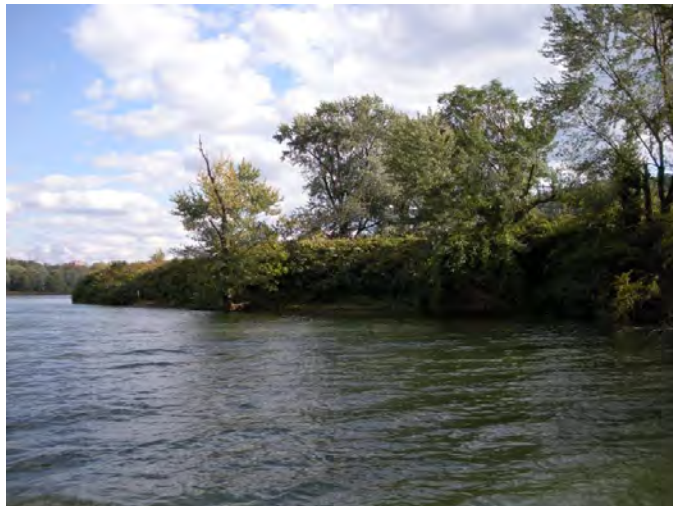
Study Area 18 was viewed by boat on October 6, 2009. There were snags in the river between the island and the north bank. There was also large debris along the riverbank. Vegetation obscured much of the view of the banks of Georgetown Island (Photograph 13).

***Photograph 13. Overview of SA 18 at North End of Georgetown Island. View West.***

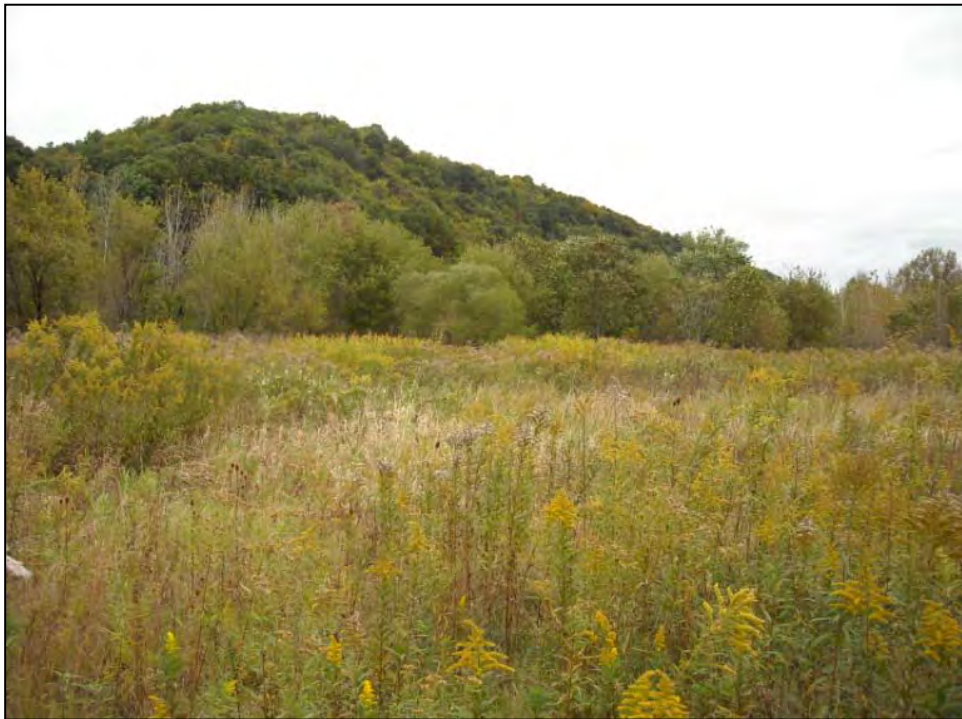
**Overview of Cleared, Disturbed Eastern Portion of Site 36BV0009. View East.**

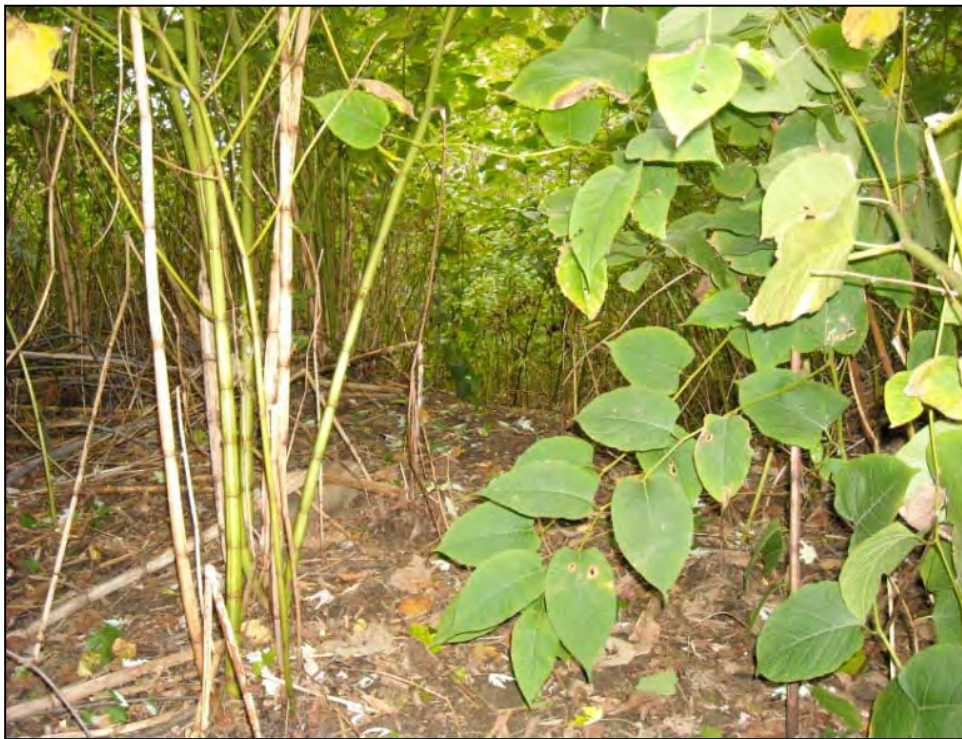
**Uneven Infilled Southern Portion of Site 36BV0009 Showing Non-native Vegetation. View North.**

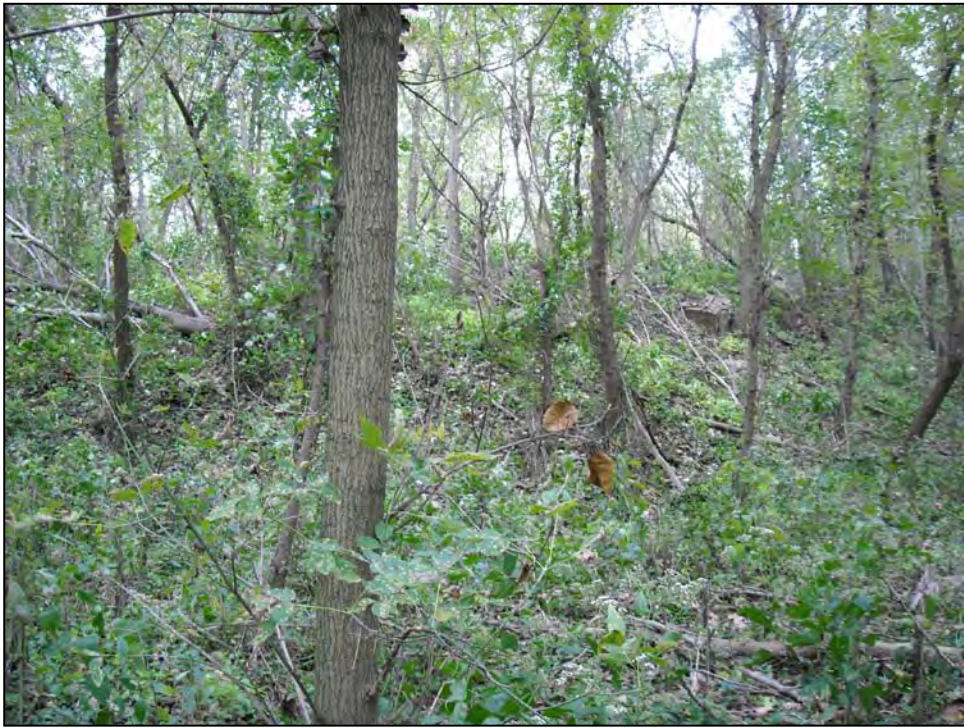
**Overview of Hummocky, Disturbed Terrain at Site 36BV0009. View East.**
